# Walkability Audit

## Inchicore National School

9 Sarsfield Rd, Kilmainham, Dublin

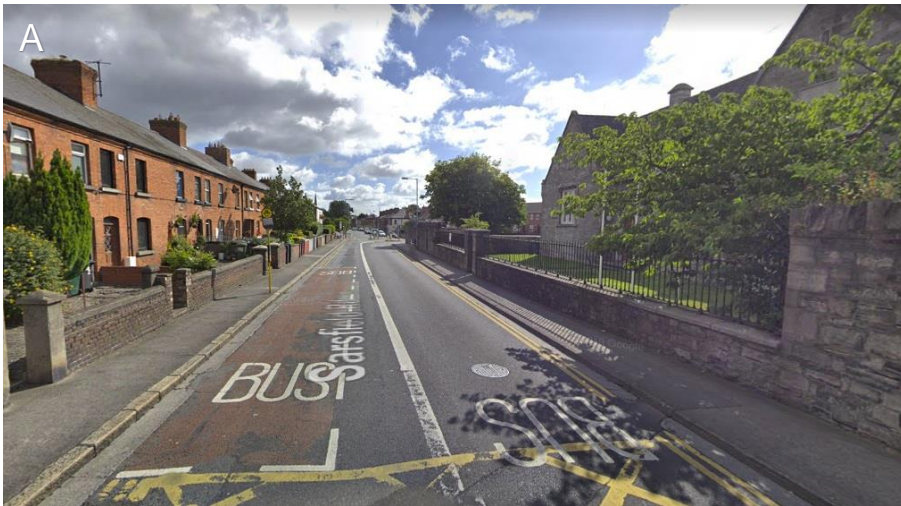
In images A & B, one can see the bus stops and bus lanes passing by the school as well as double yellow lines directly outside the school to prevent parking at the entrance. In images B & C, then, guard rails are visible, preventing pedestrians from walking onto the road.

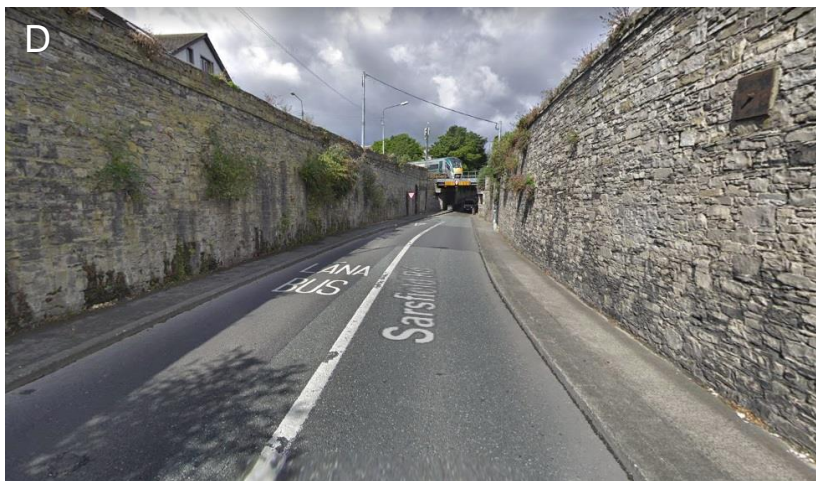
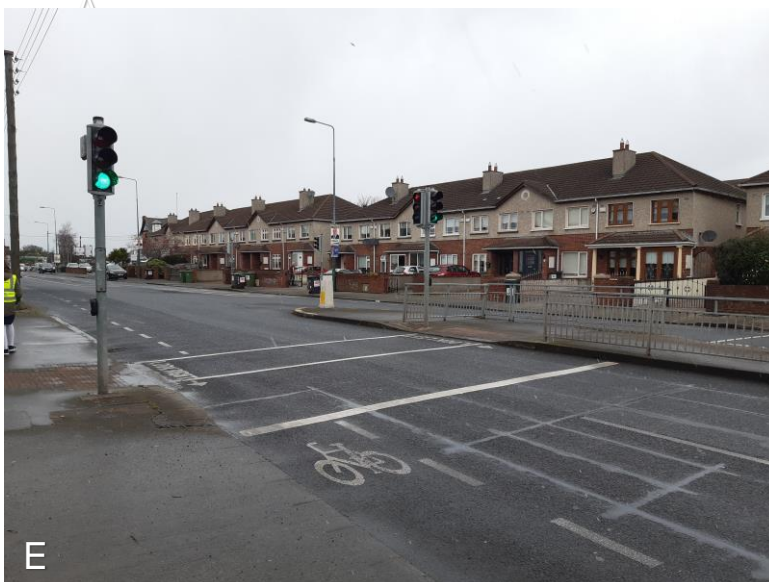
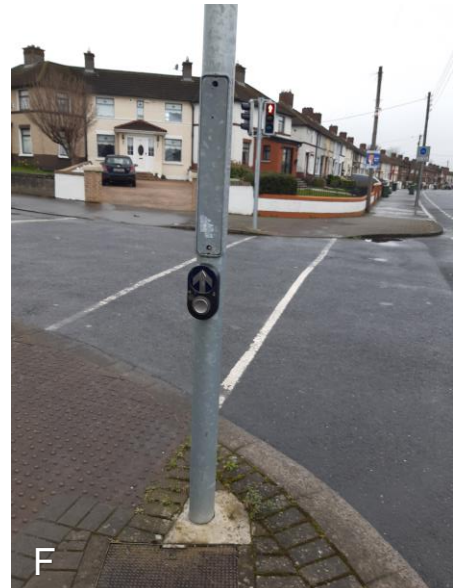
In images D, E and F street lighting is visible along Sarsfield Road, which positively contributes to the safety and attractiveness of the route. Lastly, in images, E & F, taken at the very end of the 600m route when Landen Road is reached, high quality pedestrian crossings are available.

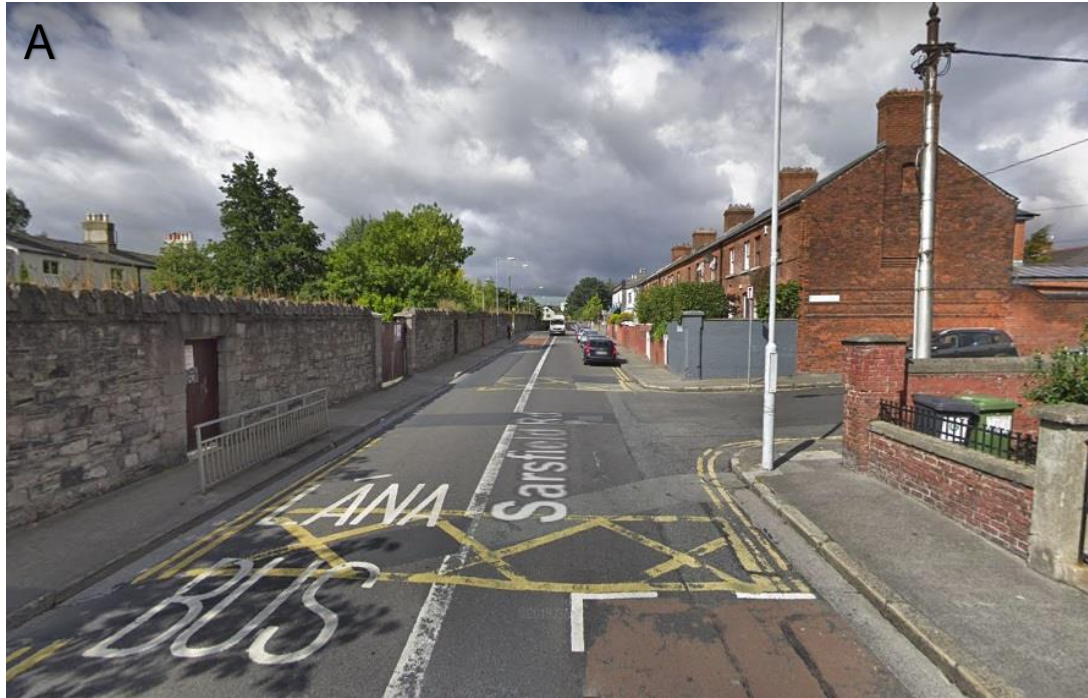
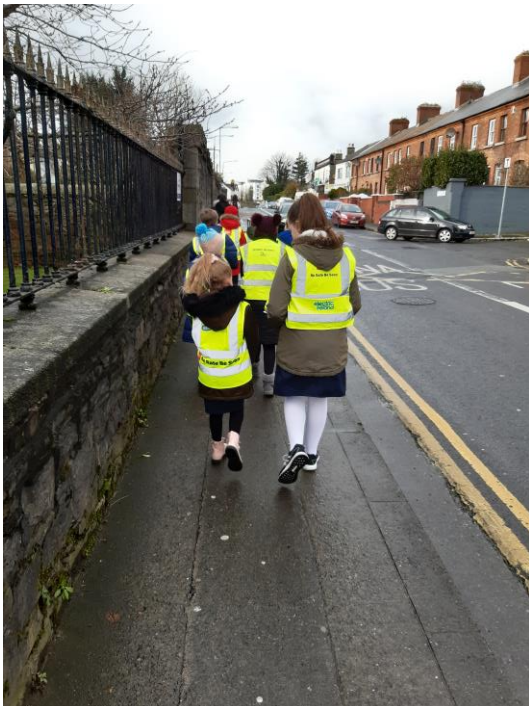
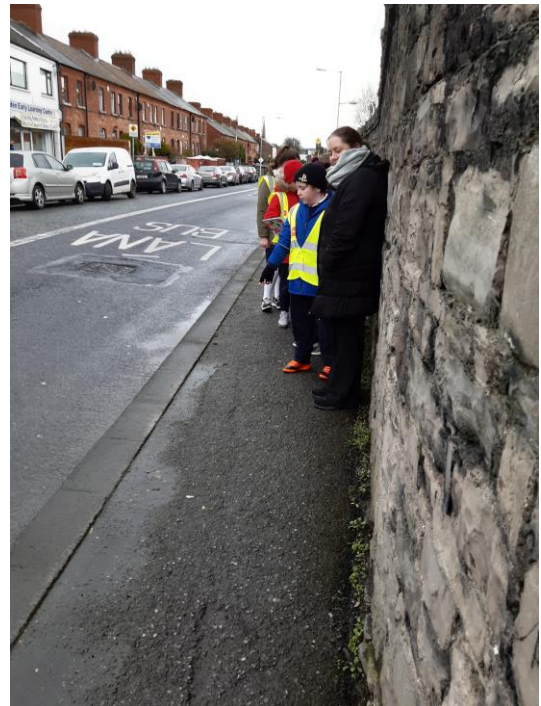
**Description:** the 600m route of Sarsfield Road that one can see marked on the map below has exceptionally narrow paths situated beside narrow traffic lanes in which traffic, including buses, appear to regularly travel at speeds of 50km/h +. No speed limit signs were encountered along this route. As a result of the traffic speed and proximity, there is a sense of exposure to traffic danger making the route feel threatening to walk, especially two abreast (as one could expect children to walk at a minimum). Crucially, due to the high speeds and narrow traffic lanes, children or pedestrians exiting the path onto the road to overtake others or walk beside others would be at risk of being hit by a vehicle. One can see in the collection of images below (collections A, B, C & D – all marked as points on the map along Sarsfield Road) the narrow widths of the pavement along the route. These pavements are not fit for groups of children who will likely spill out onto the road when travelling in groups.

**Recommendations:** widen the pavements along this important route to school, with priority given to the immediate pavement outside Inchicore National School (point A; image collection A).

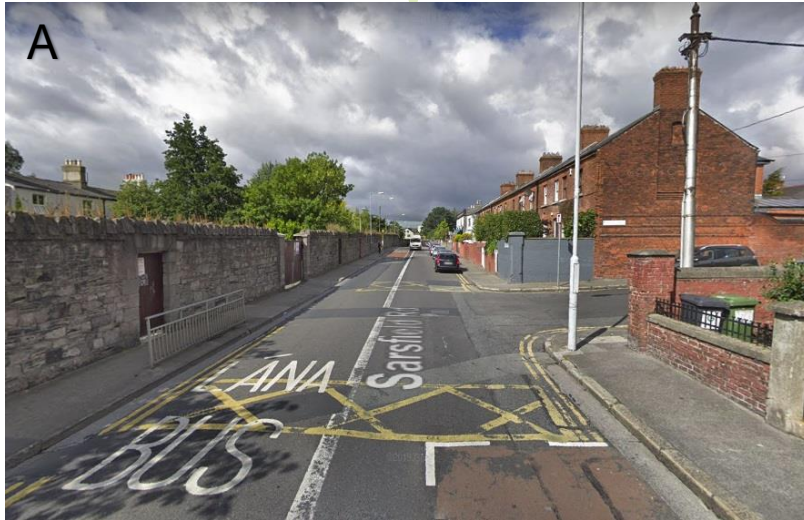
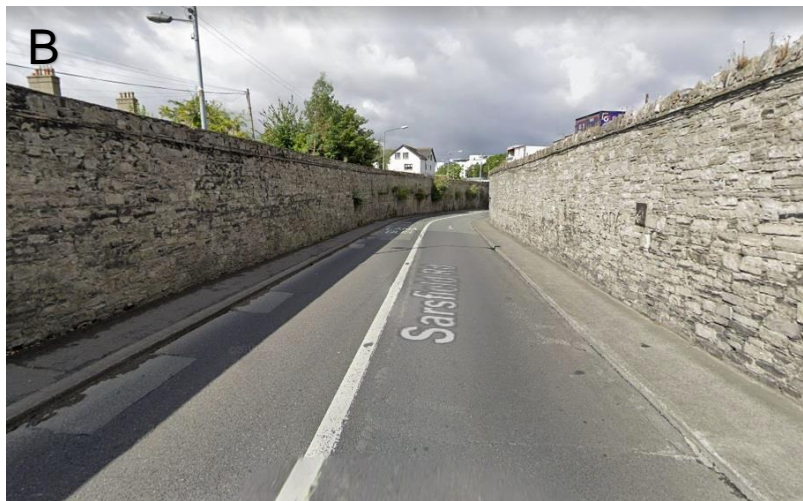
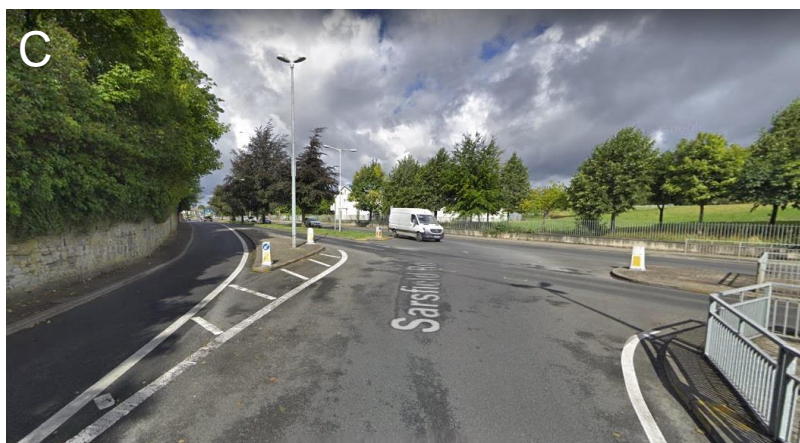
**Description:** one can see in images A, B & C along the Sarsfield Road no traffic calming in the form of speed bumps, speed limit signs or school signage despite having a school situated on the road. Along with exceptionally narrow paths as described in Issue 1, one can assume the speed limit is 50km/h for drivers and there are no measures to indicate school children nearby and to slow down vehicles, making this location very dangerous and threatening for pedestrians. In design, then, this space gives heavy priority to vehicular traffic with minimal consideration for the safety and comfort of pedestrians.

Issue 2: install multiple speed bumps along this section of Sarsfield Road to slow vehicular traffic.

Issue 3: designate 30km/h speed limits along this section either during school starting and finishing hours or permanently, with ample signage.

Issue 4: erect school signage to indicate to drivers the presence of school children walking.

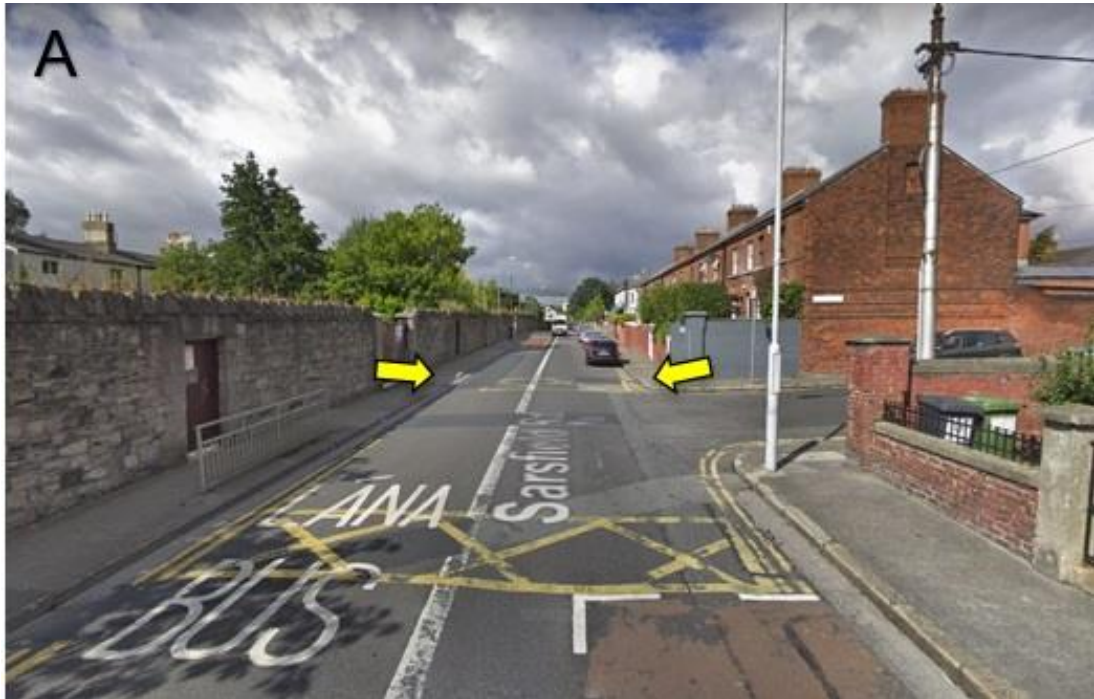
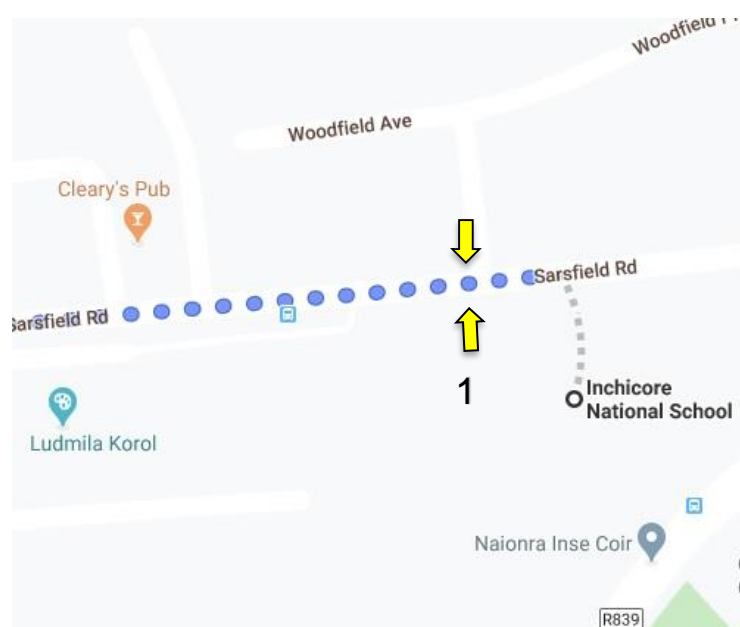
**Description:** along the 600m audit route, no formal pedestrian crossings were encountered except for at the very end beside Landen Road. Accordingly, there are no safe crossing points for pedestrians. Considering the absence of traffic calming, 30km/h speed limits, and school signage, coupled with the young age of the students in Inchicore National School, the absence of formal pedestrian facilities along this route is particularly dangerous. Furthermore, the absence of formal crossings would likely lead to risky informal crossings being made. Indeed, image H shows a memorial for a pedestrian that was killed while informally crossing near Point 5 on the map below.

**Recommendations:** install multiple formal pedestrian crossings (e.g. pelican) at regular intervals along 600m audit route. Some suggested formal crossing locations are indicated on map below (Points 1 – 5) and accompanying pages with image and map indications for more detail: Point 1 (Image A), Point 2 (Image B), Point 3 (Image C & D), Point 4 (Image E & F), Point 5 (Image G & H) .

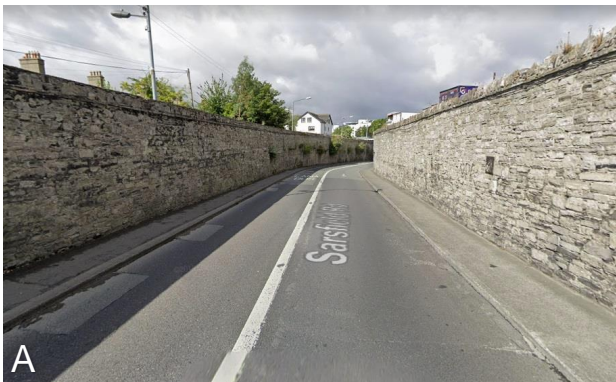
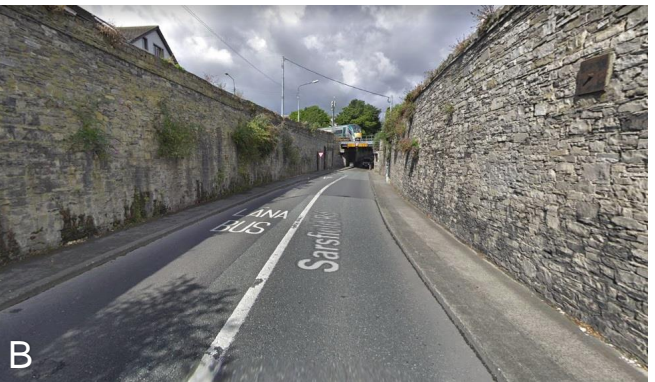
**Description:** between these two points, there are no overlooking houses or shopfronts but instead high walls (image A) with lighting and a bridge underpass (image B). This gives this section of the route an isolated and 'hemmed-in' feel since, other than passing vehicles, there is no surveillance and nowhere to escape or avoid others encountered along this route.

**Recommendations:** potentially install CCTV cameras with signage to make pedestrians aware that the area is under surveillance to make the route feel safer and more secure. More powerful lighting could also be considered.

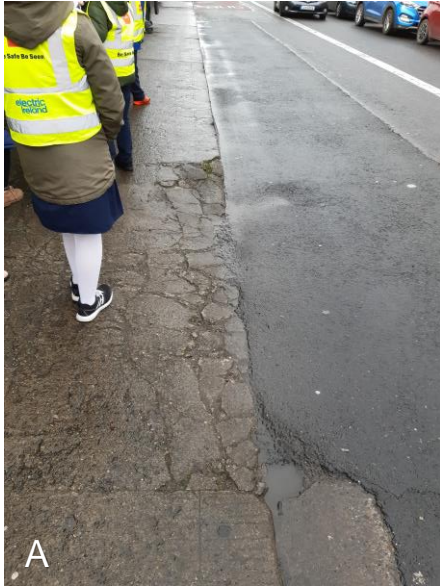
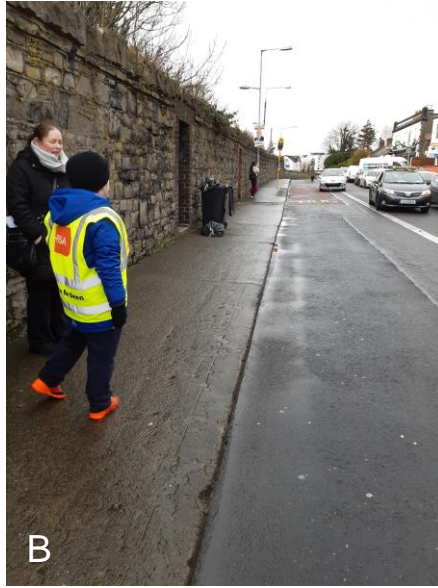
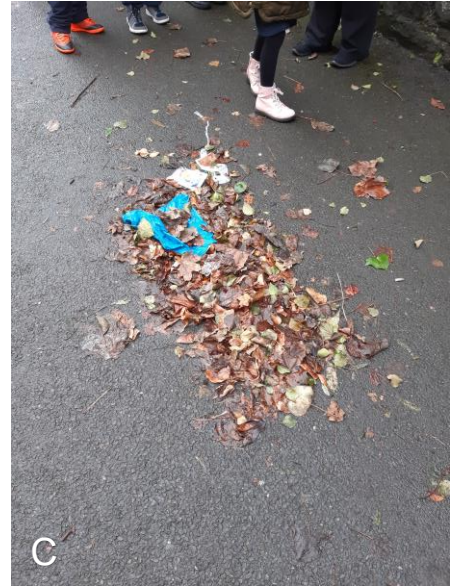
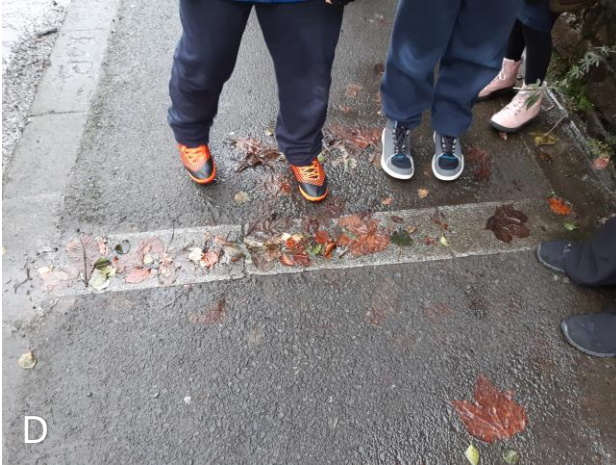
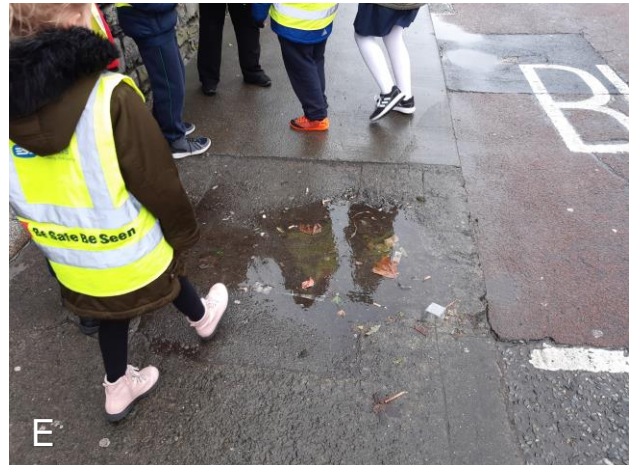
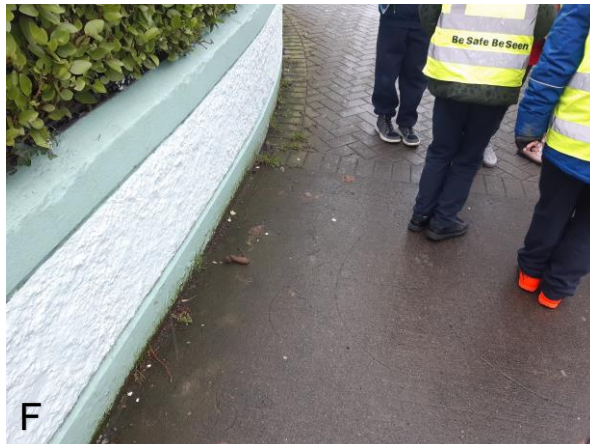
**Description:** images A – F show various issues with the path surface encountered by students on the audit: damaged pavement surface (A), bins obstructing pedestrians (B), rubbish and leaves (C), wet leaves (D), puddles (E) and dog fouling (F).

**Recommendations:** for damaged surfaces (A) and puddles (E), maintenance/drainage work could be carried out by the Council. For leaves (C and D) cleaning services could be increased by the Council. For rubbish (C) and dog fouling (F), bins could be installed along the route, *provided paths are widened in sections.*
