# Walkability Audit

## Inchicore National School

9 Sarsfield Rd, Kilmainham, Dublin

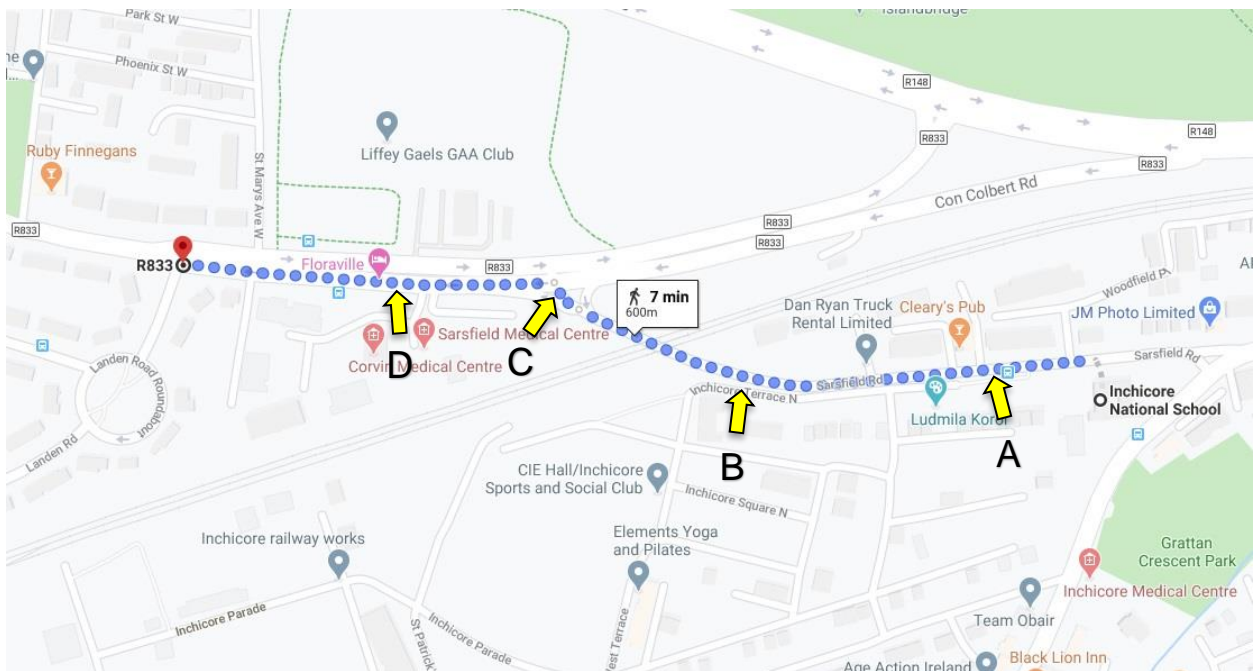
**Location:** majority of 600m walking route on Sarsfield Road.

**Description:** the 600m route of Sarsfield Road that one can see marked on the map below has exceptionally narrow paths situated beside narrow traffic lanes in which traffic, including buses, appear to regularly travel at speeds of 50km/h +. No speed limit signs were encountered along this route. As a result of the traffic speed and proximity, there is a sense of exposure to traffic danger making the route feel threatening to walk, especially two abreast (as one could expect children to walk at a minimum). Crucially, due to the high speeds and narrow traffic lanes, children or pedestrians exiting the path onto the road to overtake others or walk beside others would be at risk of being hit by a vehicle. One can see in the collection of images below (collections A, B, C & D – all marked as points on the map along Sarsfield Road) the narrow widths of the pavement along the route. These pavements are not fit for groups of children who will likely spill out onto the road when travelling in groups.

**Recommendations:** widen the pavements along this important route to school, with priority given to the immediate pavement outside Inchicore National School (point A; image collection A).

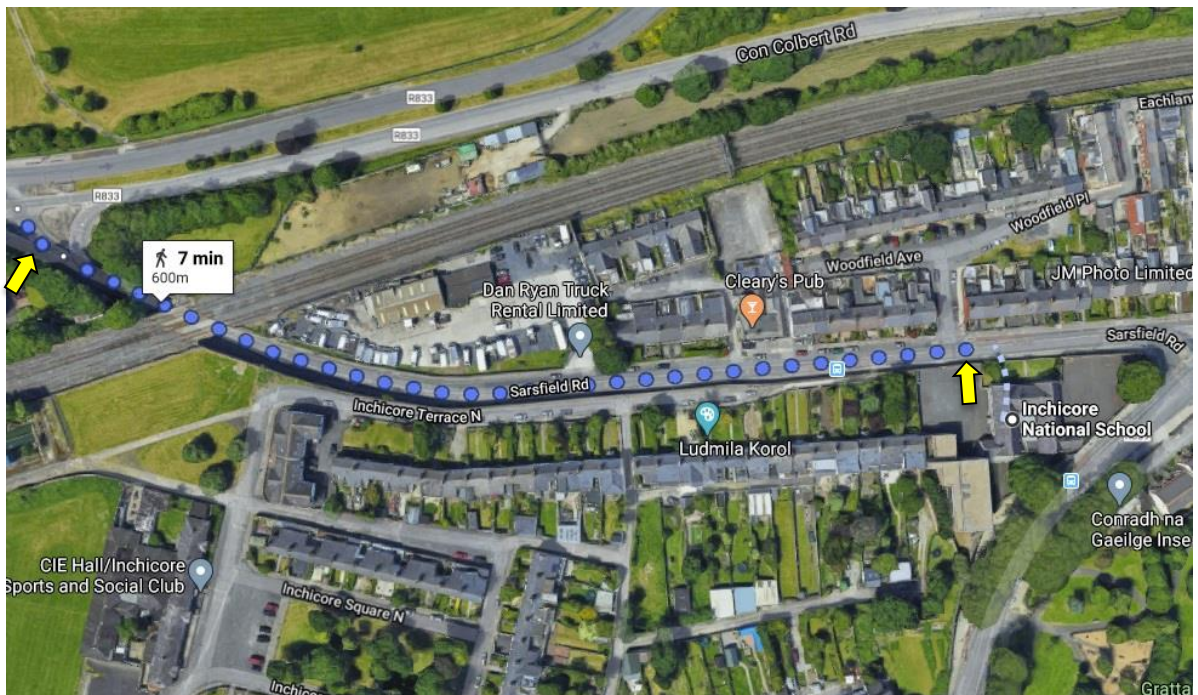
**Location:** Sarsfield Road between two arrows indicated on map.

**Description:** one can see in images A, B & C along the Sarsfield Road no traffic calming in the form of speed bumps, speed limit signs or school signage despite having a school situated on the road. Along with exceptionally narrow paths as described in Issue 1, one can assume the speed limit is 50km/h for drivers and there are no measures to indicate school children nearby and to slow down vehicles, making this location very dangerous and threatening for pedestrians. In design, then, this space gives heavy priority to vehicular traffic with minimal consideration for the safety and comfort of pedestrians.

Issue 2: install multiple speed bumps along this section of Sarsfield Road to slow vehicular traffic.

Issue 3: designate 30km/h speed limits along this section either during school starting and finishing hours or permanently, with ample signage.

Issue 4: erect school signage to indicate to drivers the presence of school children walking.

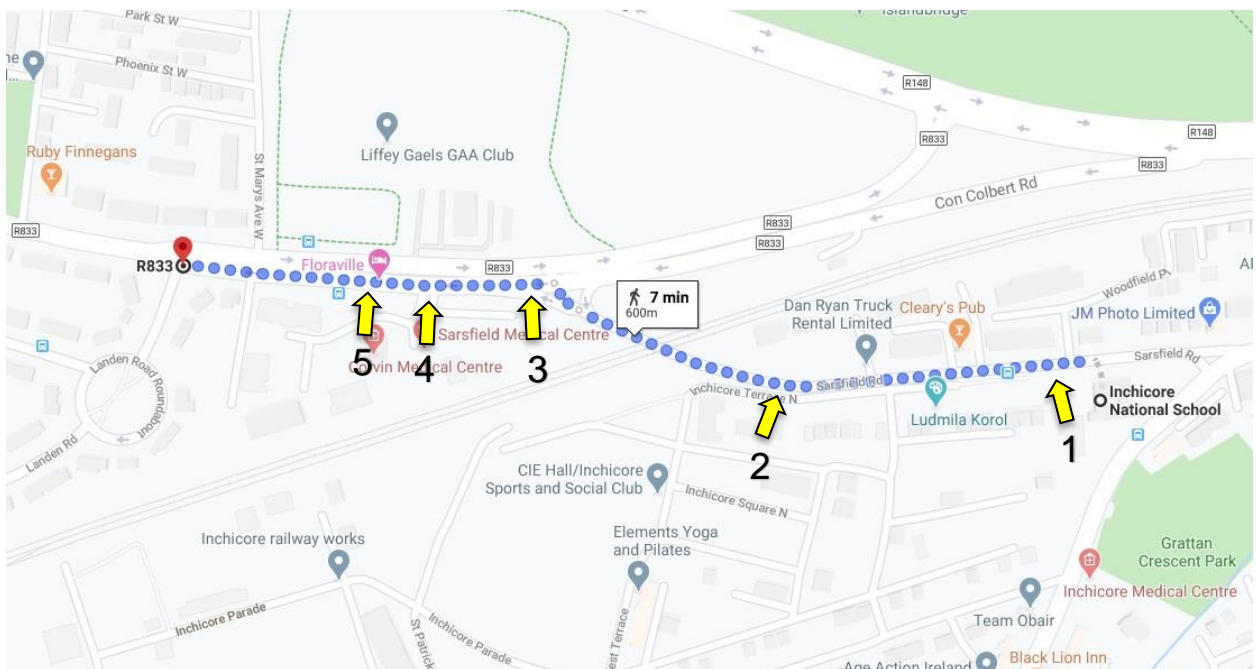
**Locations:** full 600m Sarsfield Road audit route

**Description:** along the 600m audit route, no formal pedestrian crossings were encountered except for at the very end beside Landen Road. Accordingly, there are no safe crossing points for pedestrians. Considering the absence of traffic calming, 30km/h speed limits, and school signage, coupled with the young age of the students in Inchicore National School, the absence of formal pedestrian facilities along this route is particularly dangerous. Furthermore, the absence of formal crossings would likely lead to risky informal crossings being made. Indeed, image H shows a memorial for a pedestrian that was killed while informally crossing near Point 5 on the map below.

**Recommendations:** install multiple formal pedestrian crossings (e.g. pelican) at regular intervals along 600m audit route. Some suggested formal crossing locations are indicated on map below (Points 1 – 5) and accompanying pages with image and map indications for more detail: Point 1 (Image A), Point 2 (Image B), Point 3 (Image C & D), Point 4 (Image E & F), Point 5 (Image G & H) .

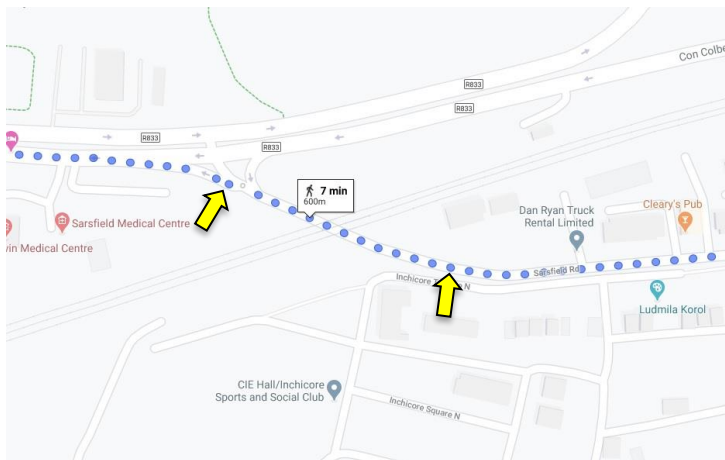
**Location:** between two points indicated with arrows on the Sarsfield Road.

**Description:** between these two points, there are no overlooking houses or shopfronts but instead high walls (image A) with lighting and a bridge underpass (image B). This gives this section of the route an isolated and 'hemmed-in' feel since, other than passing vehicles, there is no surveillance and nowhere to escape or avoid others encountered along this route.

**Recommendations:** potentially install CCTV cameras with signage to make pedestrians aware that the area is under surveillance to make the route feel safer and more secure. More powerful lighting could also be considered.

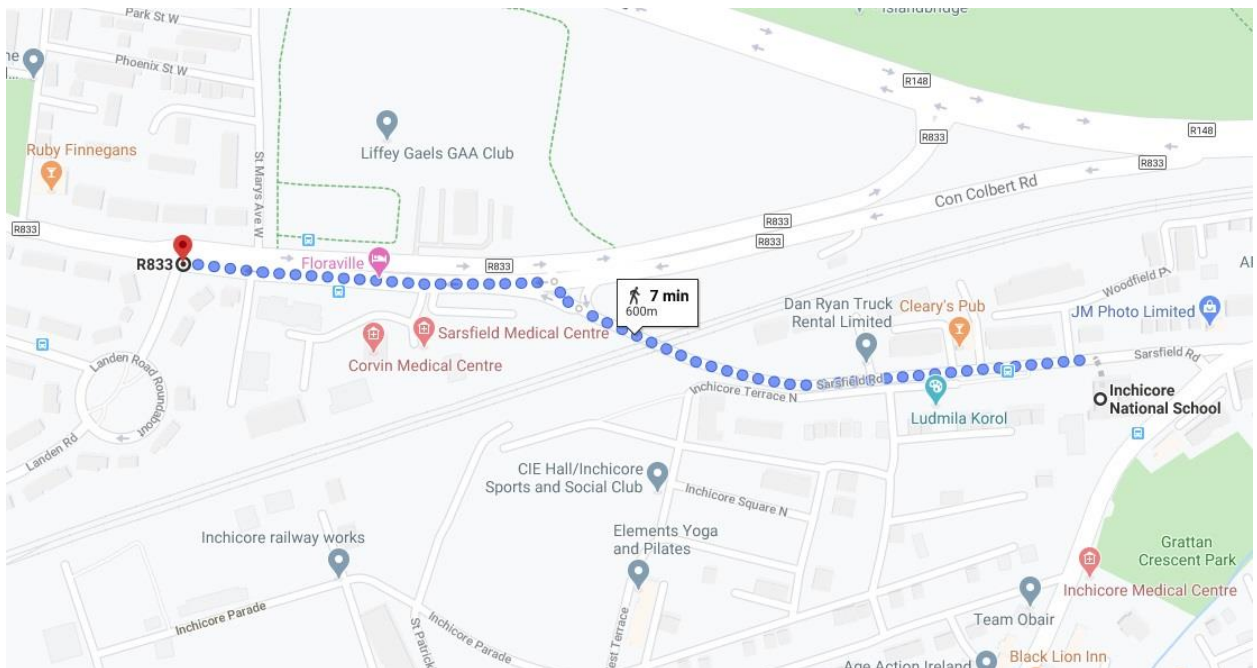
**Location:** multiple points throughout entire route along Sarsfield Road (map of entire route below).

**Description:** images A – F show various issues with the path surface encountered by students on the audit: damaged pavement surface (A), bins obstructing pedestrians (B), rubbish and leaves (C), wet leaves (D), puddles (E) and dog fouling (F).

**Recommendations:** for damaged surfaces (A) and puddles (E), maintenance/drainage work could be carried out by the Council. For leaves (C and D) cleaning services could be increased by the Council. For rubbish (C) and dog fouling (F), bins could be installed along the route, *provided paths are widened in sections.*
